**Flood Control Project Maintenance  
Levee Inspections**

**Fall 2019 Levee Maintenance Deficiency Summary Report**

**Flood Control Project Maintenance  
Levee Inspections****LMA District Cover Sheet****Fall 2019 Levee Inspection Results****Sutter Maintenance Yard East-West Interceptor**

**Sutter Maintenance Yard East-West Interceptor**

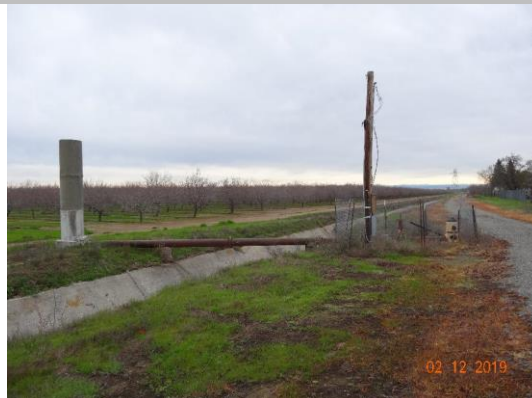
Photo 3 of 3 : UCIP\_FA\_2019\_55464\_78912.jpg

Comment Code						
Inspector Comment						
DS_ID:19417 FS_ID:55464 EP_NO: N/A Repair Type: Non-Urgent Crossing Status: Found UCIP Comments: 02/12/2019 Groundwater system does not cross high ground section (known as project levee). Record will remain part of UCIP's inventory however, pipe does not go through the designated project levee. Record remains Non-Urgent, no permit has been found authorizing this crossing. Groundwater well appears to be abandoned. The power meter has been removed. (O. Magana - DWR UCIP)4/10/2017 Crossing appears to have been abandoned. (DWR Sutter Yard- AFreitag)4/19/2016 Meter has been removed from the power box and the power lines have been disconnected from the pole and pump. Appears this crossing may have been abandoned.05/12/2015 Crossing appears in good condition. No noticeable issues to report.11/17/2014 Same as last inspection.5/12/2014 Same as last inspection.11/4/2013 Same as last inspection.5/15/2013 Same as last inspection. FIELD_STRUCT_DESC: *NOT THROUGH LEVEE* 12-inch steel irrigation pipe crosses over canal above crown elevation. Chain link enclosure on the landside (LS) with pump, power line, and shutoff valve. 24-inch concrete standpipe on unprotected side of canal. [Additional Reference(s): DWR Levee Log, Revised 1990] FS Date: 2/12/2019 10:18:00 AM

WS view: groundwater pipe system located on WS and across opposite bank.

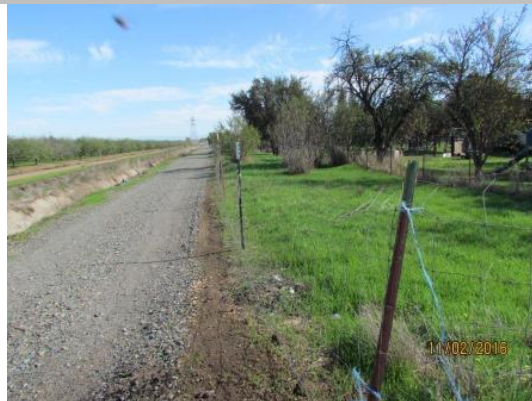
Photo 1 of 1 : FA\_2019\_ST0020\_213\_16\_20190822\_00004.jpg

LM Start	0.94	Rating **	M	Issue No.	16
LM End	0.98	Issue Type +	En	Location *	LS
Category	Earthen Levee			GPS Latitude/Longitude	
				Start	End
Item	Encroachments			39.171333 °	39.171333 °
				-121.742577 °	-121.741827 °
DWR ID	DWR_ST0020_01_f_2016_16				
Comment Code					
FE : Fence					
Inspector Comment					
The fence should be removed from the landside shoulder.

View of an unauthorized fence by a landowner.

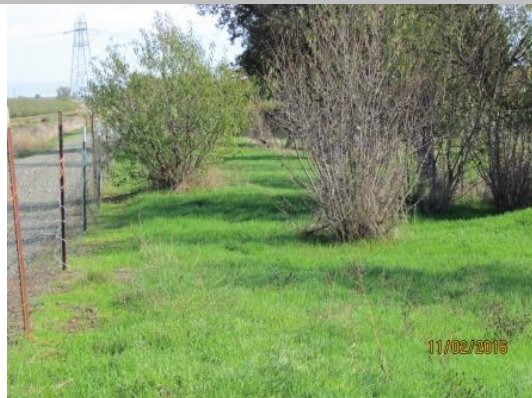
Photo 1 of 1 : FA\_2019\_ST0020\_213\_17\_20190822\_00005.jpg

View of the nut trees planted by a landowner.

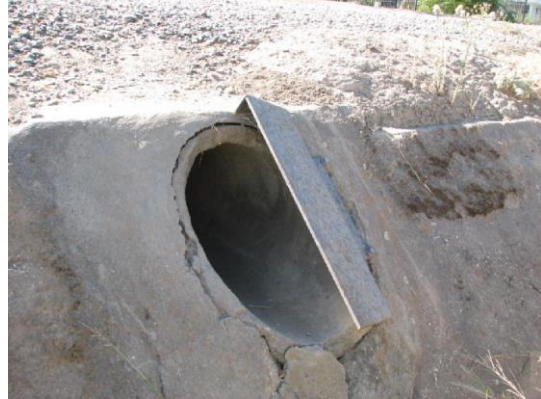
Photo 1 of 3 : UCIP\_FA\_2019\_55465\_11345.jpg

DS\_ID:19434  
FS\_ID:55465  
EP\_NO: 12746-1  
Repair Type: Non-Urgent  
Crossing Status: Found  
UCIP Comments: 02/12/2019 Unit 1 known as the West Levee (West Interceptor Canal) is considered a high ground levee with no defined levee prism, any issue found along this Unit will be considered a maintenance issue or an unauthorized encroachment. Steel deflector has been removed (2018) and replaced with 24-inch flap gate. Record remains Non-Urgent, recommend an internal inspection due to potential maintenance issues along the joints (see photo dated 2019-02-12 10:48) of the pipe. (O. Magana - DWR UCIP)4/10/2017 Overgrown vegetation blocking access to pipe. Could not be inspected. (DWR Sutter Yard- AFreitag)10/11/2016 Crossing appears to be in good condition. Still no flap gate installed on the WS but unsure if its even necessary. (DWR Sutter Yard - afreitag)4/19/2016 Crossing appears to be in good condition. Still no flap gate installed on the WS but unsure if its even necessary. (DWR Sutter Yard - afreitag)5/12/2015 Still no flap gate on pipe end but I believe the LS inlet is high enough to not allow water to flow through pipe. (DWR Sutter Yard - afreitag)11/17/2014 Same as last inspection. (DWR Sutter Yard - afreitag)5/12/2014 Same as last inspection. (DWR Sutter Yard - afreitag)11/4/2013 Same as last inspection. (DWR Sutter Yard - afreitag)5/15/2013 Same as last inspection. (DWR Sutter Yard - afreitag)10/16/2012 There is no flap gate or other device to prevent water from flowing back through the pipe at the outlet. (DWR UCIP - wwylie)

Outlet in channel with steel deflector over pipe outlet.

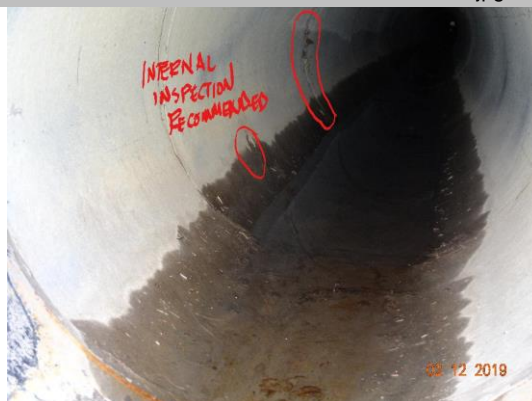
Photo 2 of 3 : UCIP\_FA\_2019\_55465\_78915.jpg

DS\_ID:19434  
FS\_ID:55465  
EP\_NO: 12746-1  
Repair Type: Non-Urgent  
Crossing Status: Found  
UCIP Comments: 02/12/2019 Unit 1 known as the West Levee (West Interceptor Canal) is considered a high ground levee with no defined levee prism, any issue found along this Unit will be considered a maintenance issue or an unauthorized encroachment. Steel deflector has been removed (2018) and replaced with 24-inch flap gate. Record remains Non-Urgent, recommend an internal inspection due to potential maintenance issues along the joints (see photo dated 2019-02-12 10:48) of the pipe. (O. Magana - DWR UCIP)4/10/2017 Overgrown vegetation blocking access to pipe. Could not be inspected. (DWR Sutter Yard- AFreitag)10/11/2016 Crossing appears to be in good condition. Still no flap gate installed on the WS but unsure if its even necessary. (DWR Sutter Yard - afreitag)4/19/2016 Crossing appears to be in good condition. Still no flap gate installed on the WS but unsure if its even necessary. (DWR Sutter Yard - afreitag)5/12/2015 Still no flap gate on pipe end but I believe the LS inlet is high enough to not allow water to flow through pipe. (DWR Sutter Yard - afreitag)11/17/2014 Same as last inspection. (DWR Sutter Yard - afreitag)5/12/2014 Same as last inspection. (DWR Sutter Yard - afreitag)11/4/2013 Same as last inspection. (DWR Sutter Yard - afreitag)5/15/2013 Same as last inspection. (DWR Sutter Yard - afreitag)10/16/2012 There is no flap gate or other device to prevent water from flowing back through the pipe at the outlet. (DWR UCIP - wwylie)

WS view: internal view of concrete pipe recommend internal inspection to determine severity of potential issues marked in red.

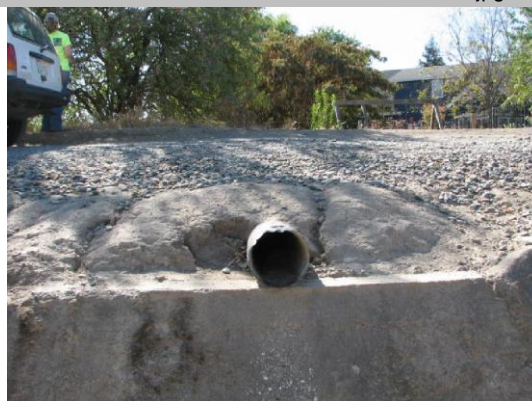
Photo 1 of 3 : UCIP\_FA\_2019\_55466\_64242.jpg

Comment Code					
Inspector Comment					
DS_ID:20115 FS_ID:55466 EP_NO: N/A Repair Type: Non-Urgent Crossing Status: Found UCIP Comments: 02/12/2019 Unit 1 known as the West Levee (West Interceptor Canal) is considered a high ground levee with no defined levee prism, any issue found along this Unit will be considered a maintenance issue or an unauthorized encroachment. Recommend clearing sediment build up inside pipe. Records remains Non-Urgent, no permit has been found authorizing pipe. (O. Magana - DWR UCIP)04/10/2017 Overgrown vegetation was blocking access to this pipe. It was not inspected. (DWR Sutter Yard- AFreitag)10/11/2016 Crossing appears to be in good condition.(DWR Sutter Yard - afreitag)04/19/2016 Crossing appears to be in good condition.05/12/2015 Crossing appears in good condition. No noticeable issues to report.11/17/2014 Same as last inspection.05/12/2014 New flap gate installed on WS pipe end.11/04/2013 Same as last inspection.05/15/2013 Same as last inspection.10/16/2012 Pipe not permitted and has no flap gate. FIELD_STRUCT_DESC: 8-inch corrugated metal drainage pipe through the levee (high ground levee), 1.5 feet below the crown. Outlet visible on the waterside (WS). Flap gate installed in 2014. Unable to locate the inlet on the landside (LS). No permit has been identified since crossing was field discovered in 2012. Pipe drains adjacent property. FS Date: 2/12/2019 10:19:00 AM

Pipe at outlet on WS crown.

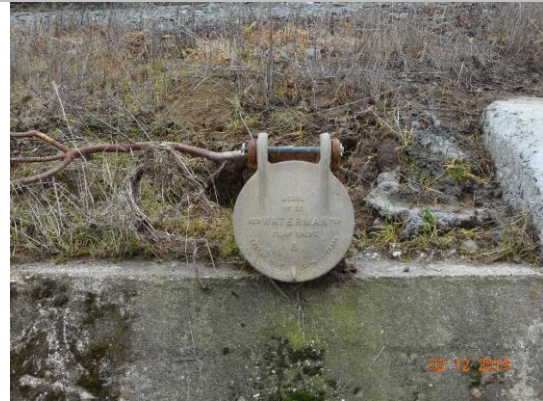
Photo 3 of 3 : UCIP\_FA\_2019\_55466\_78922.jpg

WS view: flap gate visible on WS.

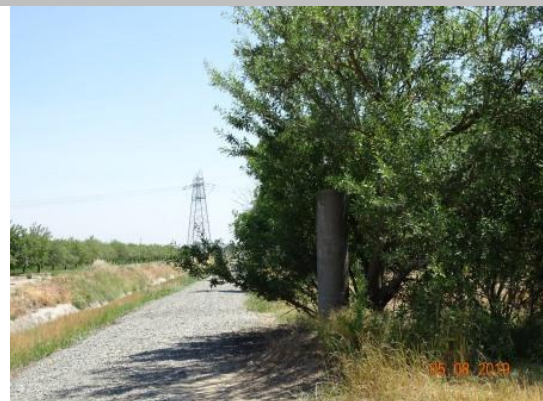
Photo 1 of 1 : FA\_2019\_ST0020\_213\_15\_20190822\_00003.jpg

LM Start	1.10	Rating **	M	Issue No.	15
LM End	1.10	Issue Type +	Ma	Location *	LS
Category	Earthen Levee			GPS Latitude/Longitude	
				Start	End
Item	Trim / Thin Trees			39.171290°	39.171290°
				-121.739639°	-121.739639°
DWR ID	DWR_ST0020_01_s_2019_15				
Comment Code					
T1 : Trim trees to at least five feet above ground level.					
Inspector Comment

View of the trees on the landside slope. Spring 2019.

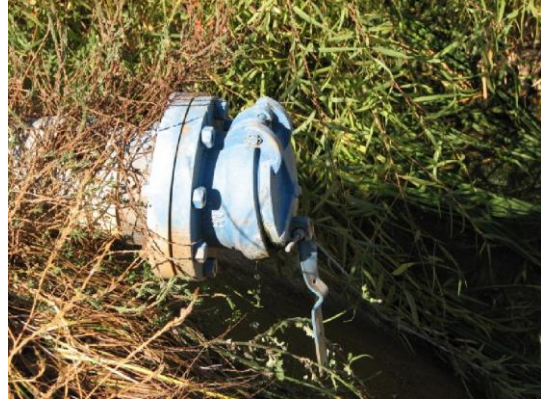
Photo 2 of 3 : UCIP\_FA\_2019\_55467\_11346.jpg

Flap gate on pipe end.

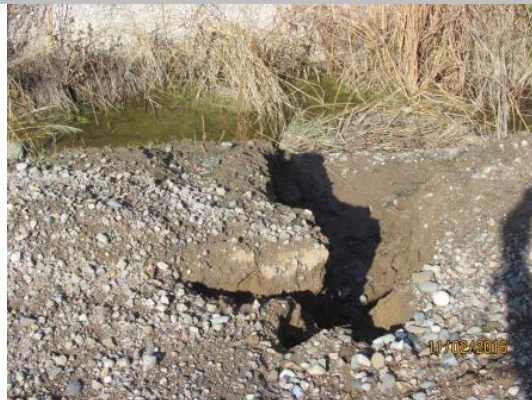
Photo 1 of 1 : FA\_2019\_ST0020\_213\_22\_20190822\_00009.jpg

View of the erosion along the bank.

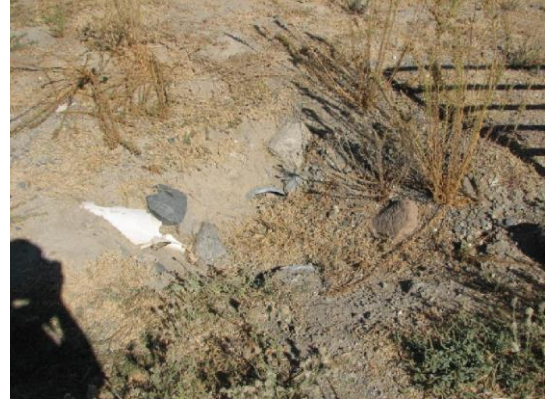
Photo 3 of 3 : UCIP\_FA\_2019\_55468\_11348.jpg

Soil filled inlet on LS of crown.

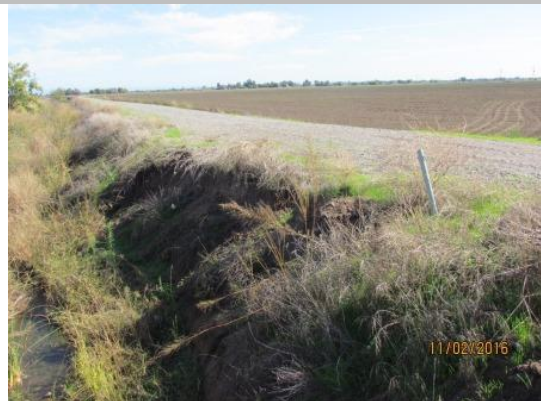
Photo 1 of 1 : FA\_2019\_ST0020\_213\_24\_20190822\_00010.jpg

View of the erosion along the bank.

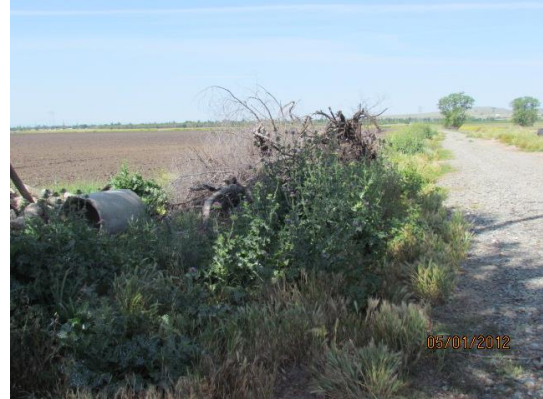
Photo 1 of 1 : FA\_2019\_ST0020\_214\_9\_20190822\_00005.jpg

View of the debris along the landside toe.

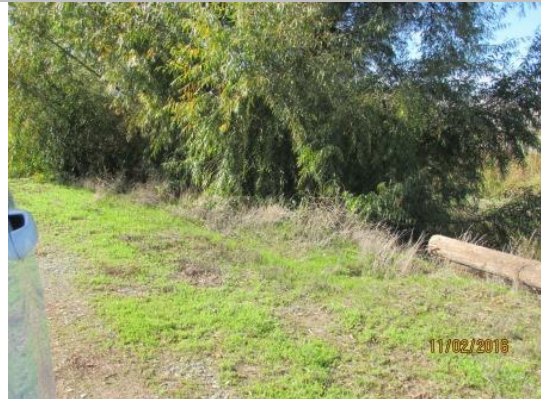
Photo 1 of 1 : FA\_2019\_ST0020\_214\_31\_20190822\_00009.jpg

View of the overgrown trees blocking visibility and access.

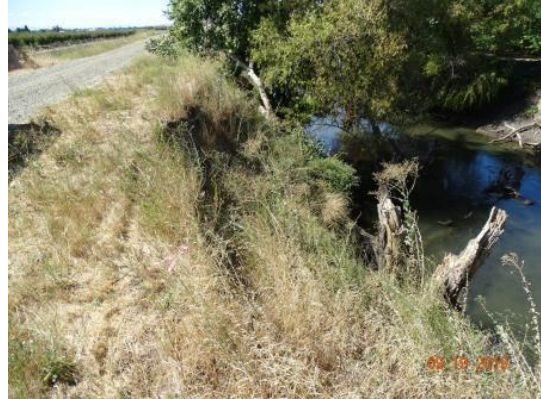
Photo 1 of 1 : FA\_2019\_ST0020\_214\_39\_20190920\_00084.jpg

View of sloughing on the waterside slope. Fall 2019.

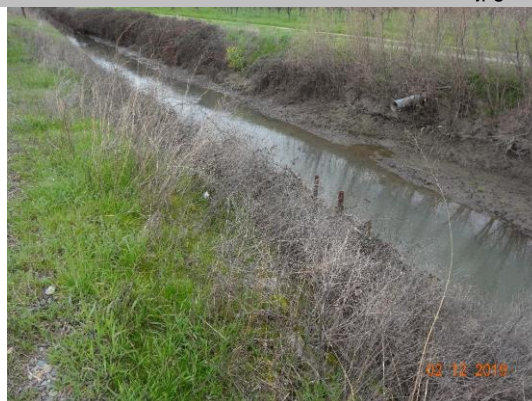
Photo 2 of 3 : UCIP\_FA\_2019\_55563\_78989.jpg

WS view: steep slope with dry vegetation along bank.

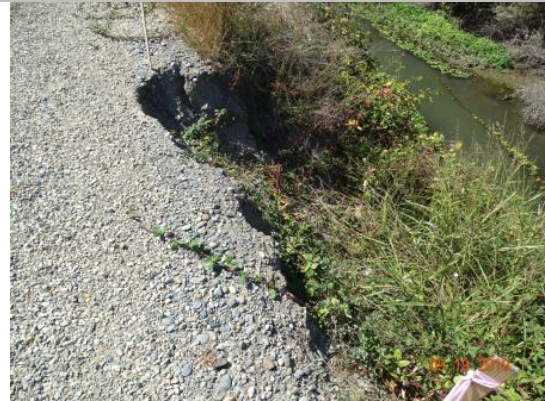
Photo 1 of 1 : FA\_2019\_ST0020\_214\_40\_20190920\_00085.jpg

View of erosion on the waterside slope/bank. Fall 2019.

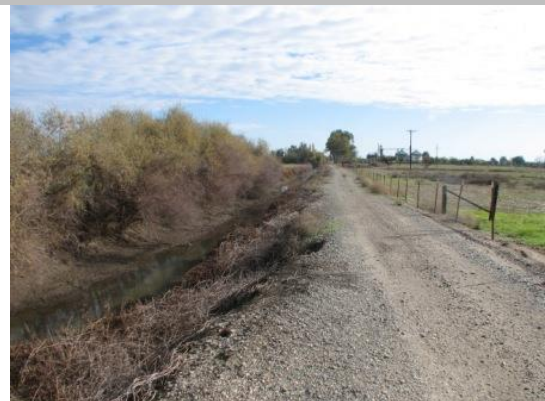
Photo 1 of 1 : FA\_2019\_ST0020\_214\_3\_20190920\_00086.jpg

View of typical erosion along the waterside slope.

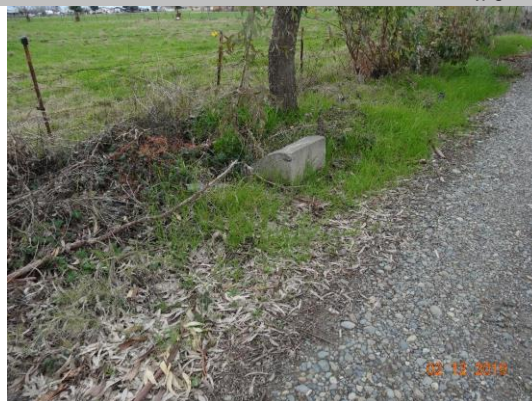
Photo 2 of 3 : UCIP\_FA\_2019\_55483\_79003.jpg

LS view: no evidence of 7-inch flexible HDPE pipe present on LS.

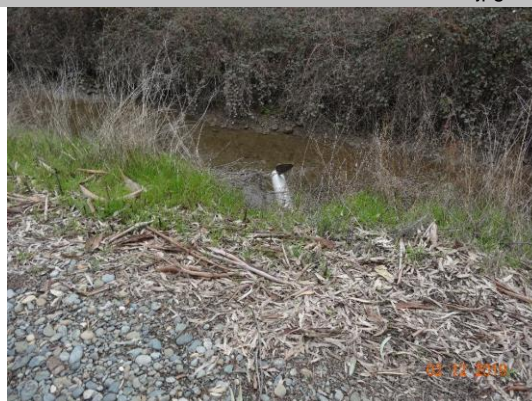
Photo 3 of 3 : UCIP\_FA\_2019\_55483\_79004.jpg

WS view: no evidence of 7-inch flexible HDPE pipe present on WS, only 5-inch steel pipe represent.

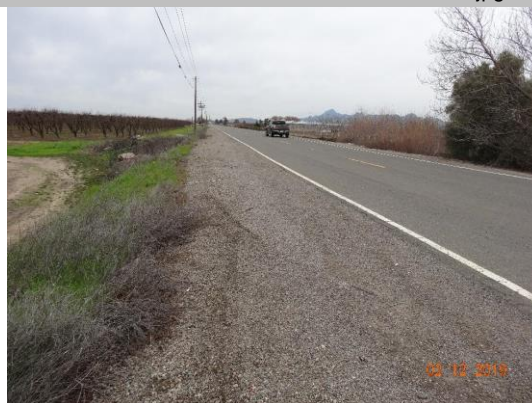
Photo 1 of 1 : UCIP\_FA\_2019\_55493\_79051.jpg

Overview of levee section where crossing should be, no evidence was found of crossing.
